THIRTIETH ANNIVERSARY OF REACTOR ACCIDENT IN A-1 NUCLEAR POWER PLANT JASLOVSKE BOHUNICE

Jozef Kuruc, Ľubomír Máteľ

Abstract

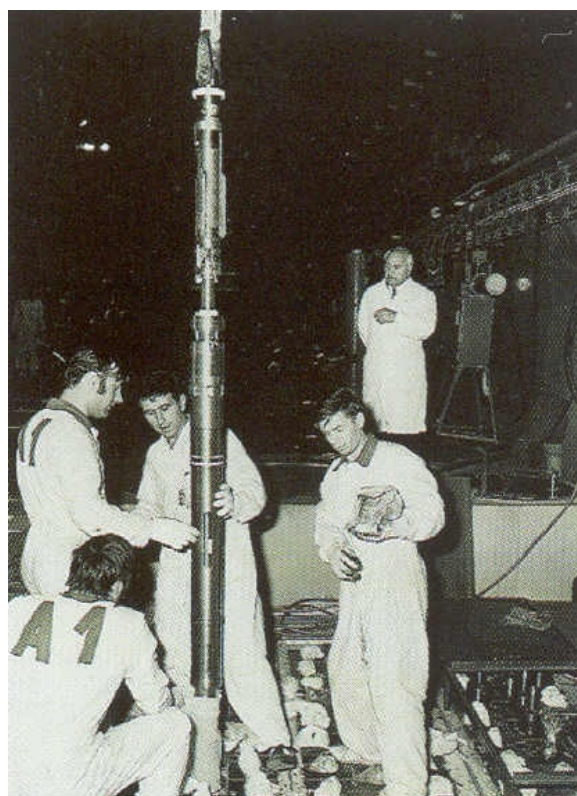
Figure 6. Landfill of fuel assembly into reactor KS-150 [5].

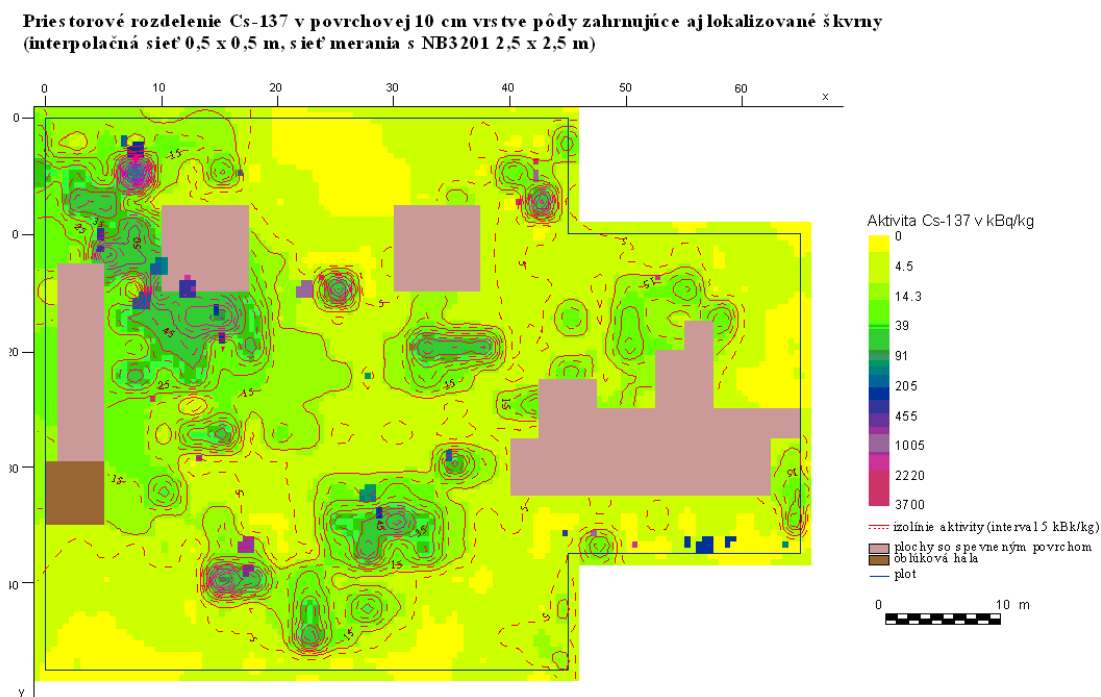
Figure 8. Surface contamination of soil by Cs-137 in area of the A-1 NPP [30].

Surface contamination of soils by cesium-137 in the area of the A-1 NPP is shown on the Figure 8.
